**PUBLIC WORKS
CENTER
YOKOSUKA, JAPAN
FLEET MOORINGS
UNDERWATER
INSPECTION
REPORT**

SEPTEMBER 1983

OCEAN ENGINEERING
AND CONSTRUCTION PROJECT OFFICE
CHESAPEAKE DIVISION
NAVAL FACILITIES ENGINEERING COMMAND
WASHINGTON, D.C. 20374

FPO-1-83 (25)

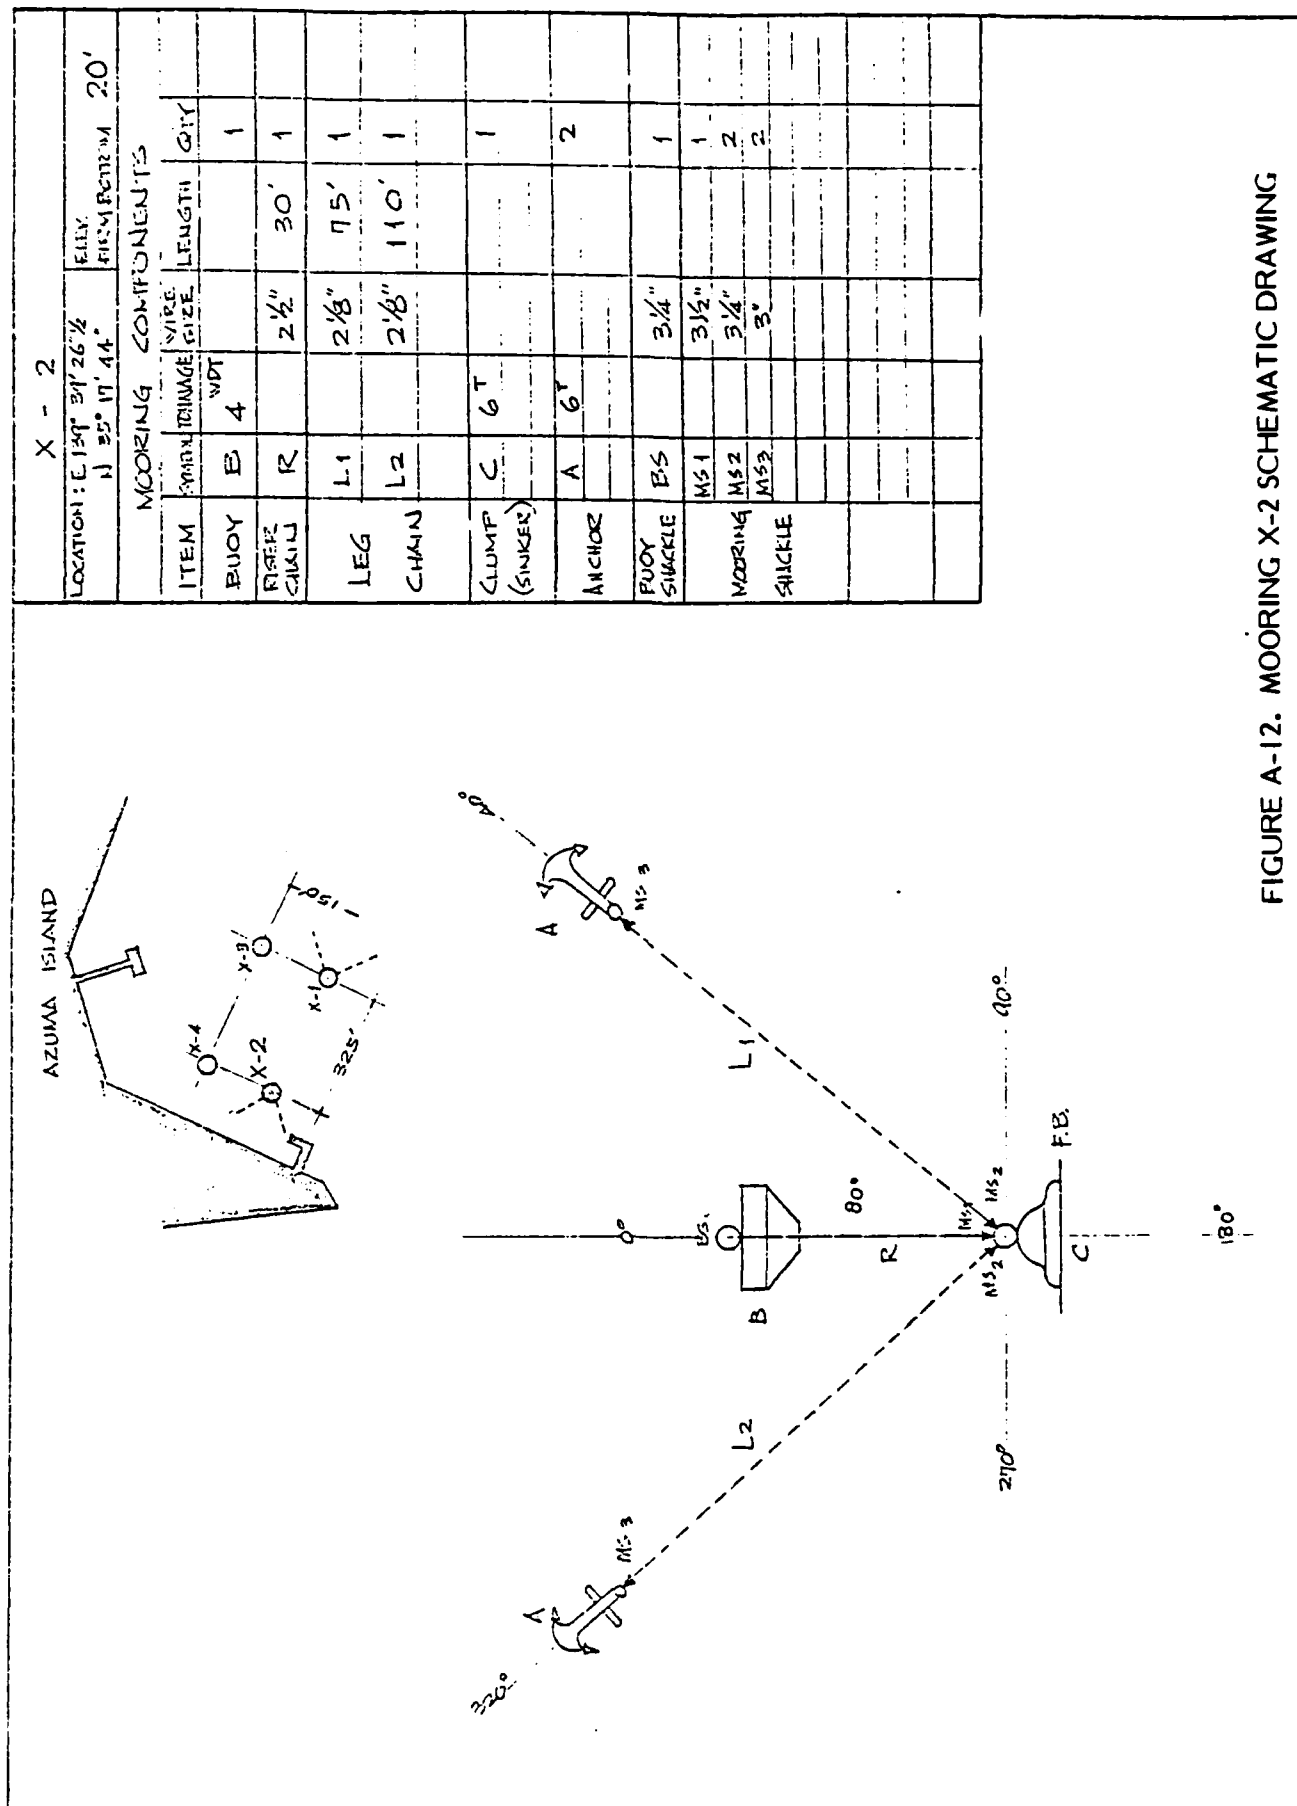
FIGURE A-12. MOORING X-2 SCHEMATIC DRAWING

COMPONENTS	NI	CONDITION						COMMENT
		NEW	SINGLE LINK %		DOUBLE LINK %		D	
BUOY HARDWARE			80+	80+	80+	80+		
								FIBERGLASS COATED. TOP
								REPAINTED. FENDERS OK. BUOY
								HAS SLIGHT LIST.
RISER								
GROUND RING								
BRNG GROUND LEG NO. A								
BRNG GROUND LEG NO. B								
BRNG GROUND LEG NO. C								
BRNG GROUND LEG NO. D

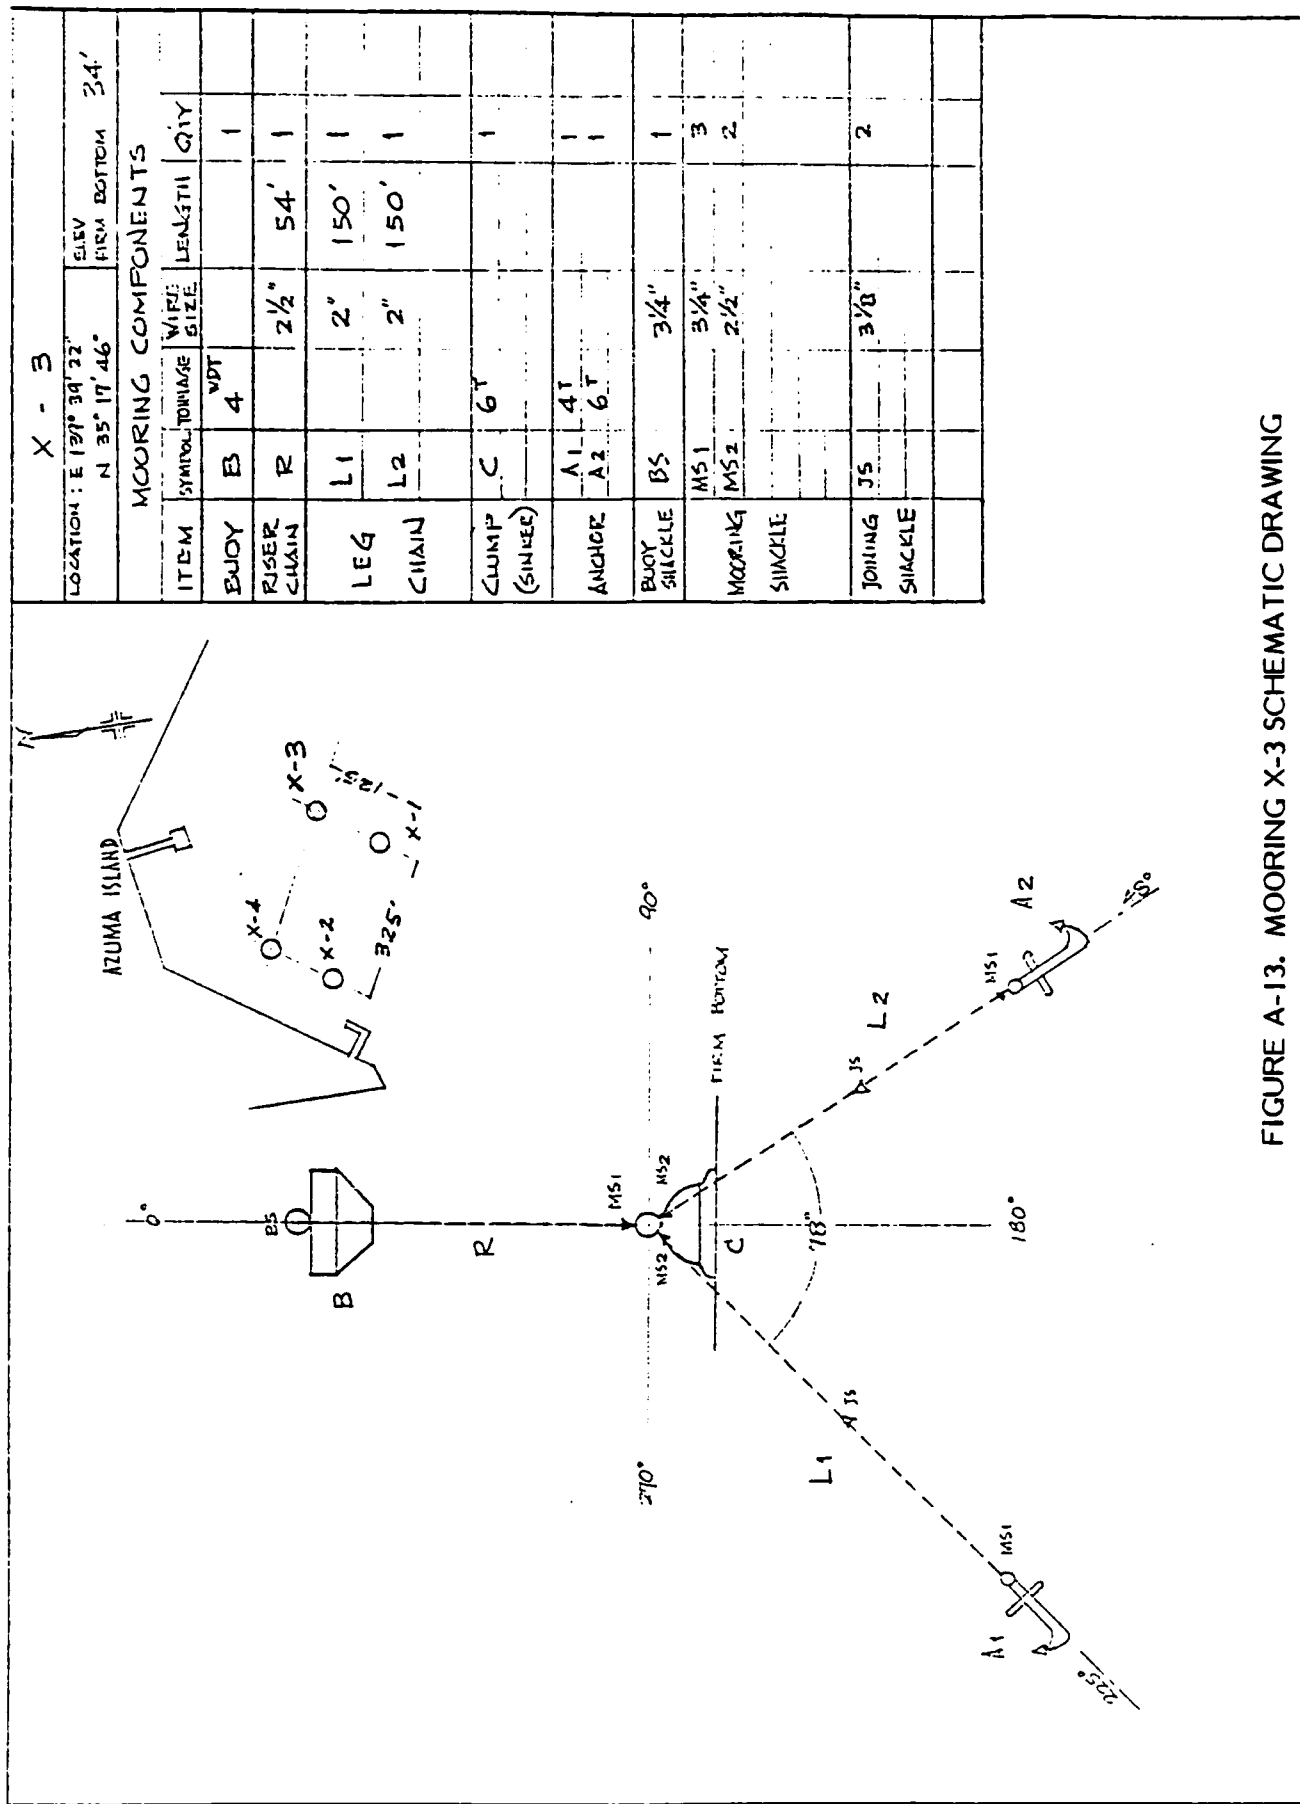
FIGURE A-13. MOORING X-3 SCHEMATIC DRAWING

COMPONENTS		NI	CONDITION							COMMENT	
			NEW	SINGLE LINK %			DOUBLE LINK %				D
				90+	80+	80-	90+	80+	80-		
BUOY HARDWARE											MODERATE RUST ON TOP. BROKEN
1 1/2" SHACKLE											CHAFING RAIL. TWO RUBBER
1 3/4" SHACKLE											FENDERS IN GOOD CONDITION.
2 3/4" SHACKLE											PARTIALLY REPAINTED
RISER CHAIN											
RISER	NEAR BUOY		2 1/2"				✓✓			10'	2 3/4" GAUGE USED
	MIDDLE		↓				✓✓			17'	
	NEAR GRD RG						✓✓			25'	ENTERS BOTTOM VERTICALLY
GROUND RING											
GROUND LEG NO. A	UPPER END										DIVERS COULD FEEL TOP OF
	MIDDLE										BORIED SINKER. GROUND LEGS
	ENTERS BOTTOM										ANCHORS / SINKER NOT VISIBLE.
GROUND LEG NO. B	UPPER END										
	MIDDLE										
	ENTERS BOTTOM										
GROUND LEG NO. C	UPPER END										
	MIDDLE										
	ENTERS BOTTOM										
GROUND LEG NO. D	UPPER END										
	MIDDLE										
	ENTERS BOTTOM

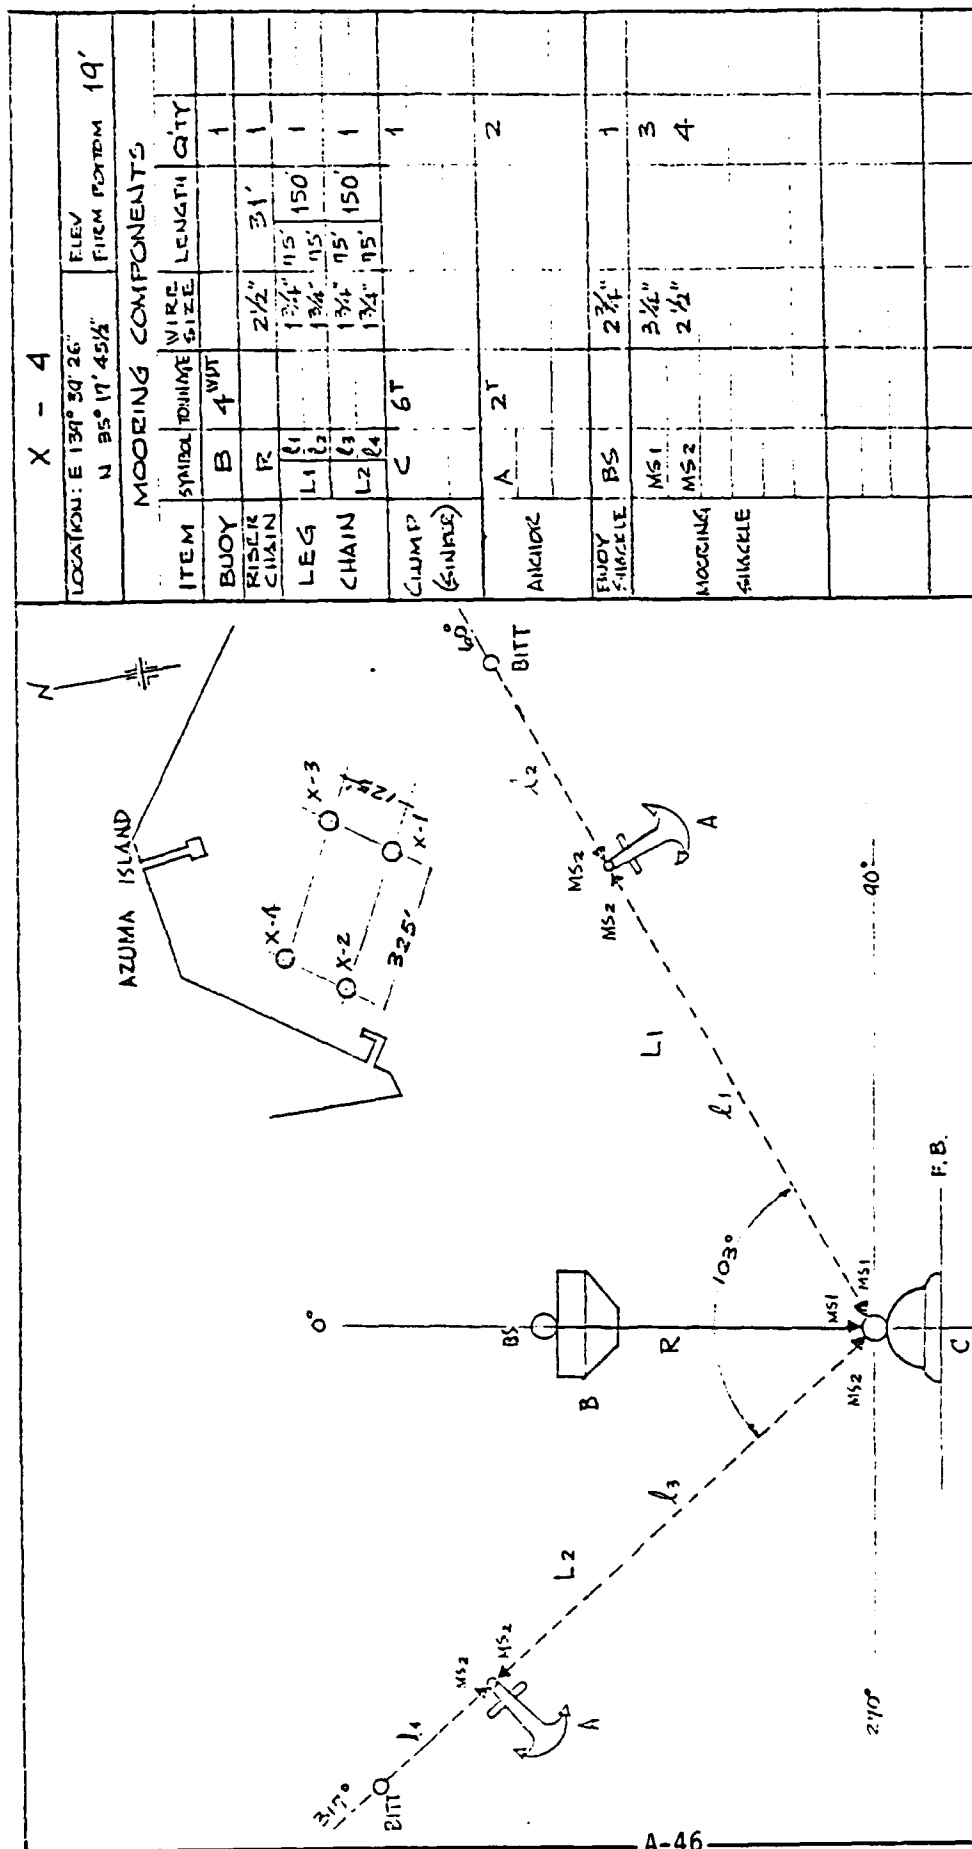
FIGURE A-14. MOORING X-4 SCHEMATIC DRAWING

COMPONENTS	NI	CONDITION							COMMENT	
		NEW	SINGLE LINK %			DOUBLE LINK %				
			90+	80+	80-	90+	80+	80-		
BUOY HARDWARE									BOUY LOOKS GOOD. NEW PAINT JOB	
1 1/2" SHACKLE										
2"										
3"										
4"										
RISER	NEAR BUOY	2 1/2"				✓✓			< 10'	10' RISER CHAIN ON BOTTOM. RISER
	MIDDLE	↓				✓✓			10'	CONNECTED TO SINKER WITH 3 1/2"
	NEAR GRD RG	✓✓							12'	SHACKLE.
GROUND RING										
BRG GROUND LEG NO. A 050°	UPPER END	1 3/4"	✓✓						12'	CONNECTED TO SINKER WITH 3 3/4"
	MIDDLE	↓								SHACKLE. ABOUT 45' VISIBLE
	ENTERS BOTTOM	✓	✓							BEFORE ENTERING BOTTOM.
BRG GROUND LEG NO. B 130°	UPPER END	1 3/4"	✓✓							CONNECTED TO SINKER WITH 3 3/4"
	MIDDLE	↓								SHACKLE. ABOUT 42' VISIBLE
	ENTERS BOTTOM	↓	✓✓						↓	BEFORE ENTERING BOTTOM.
GROUND LEG NO. C	UPPER END									
	MIDDLE									
	ENTERS BOTTOM									BOTH LEGS CLEAN BUT RUSTY.
GROUND LEG NO. D	UPPER END									
	MIDDLE									
	ENTERS BOTTOM									SINKER/ANCHORS BURIED

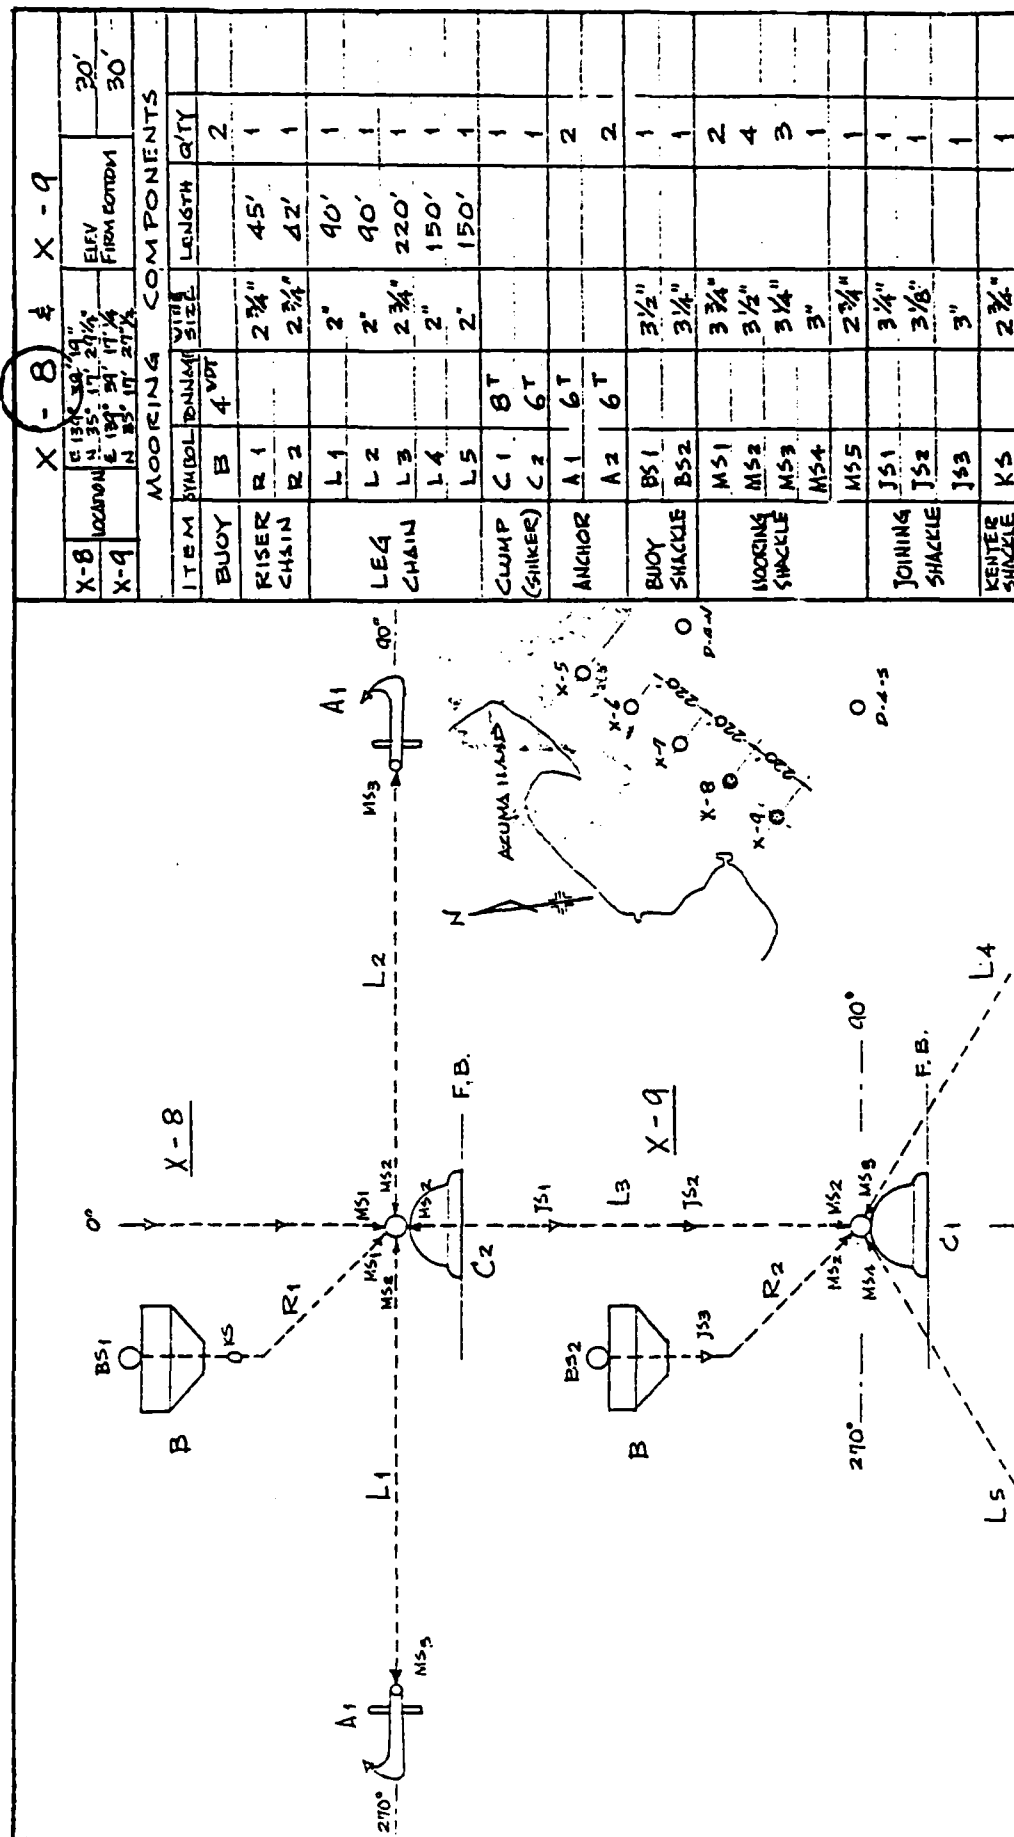
FIGURE A-18. MOORING X-8 SCHEMATIC DRAWING

COMPONENTS	NI	CONDITION						COMMENT
		NEW	SINGLE LINK %		DOUBLE LINK %		D	
BUOY HARDWARE			90+	80+	80-	80+	80-	
								FIBERGLASS COATING / RUBBER FENDERS
								OK. CHAIN LINKS AT TOP OF HANSE
								PIPE BADLY PITTED. RUST BLEEDING ON TOP AND SIDE OF BUOY.
RISER								
		<u>2 3/4"</u>			<u>VVV</u>		<u>< 10'</u>	ABOUT TEN FEET ON BOTTOM PRIOR
		<u>↓</u>			<u>VVV</u>		<u>15'</u>	TO CONNECTION VIA 3" ENDLINK
GROUND RING							<u>28"</u>	AND 4" SHACKLE TO SNIPER.
							<u>28'</u>	VISIBILITY VERY POOR
BENG GROUND LEG NO. A NORTH		<u>2"</u>						
		<u>↓</u>						
BENG GROUND LEG NO. B EAST		<u>2"</u>					<u>28'</u>	2 1/2" GAUGE USED ON LEGS
		<u>↓</u>						
BENG GROUND LEG NO. C WEST		<u>2 3/4"</u>					<u>28'</u>	
		<u>↓</u>						
GROUND LEG NO. D								ANCHORS BURIED

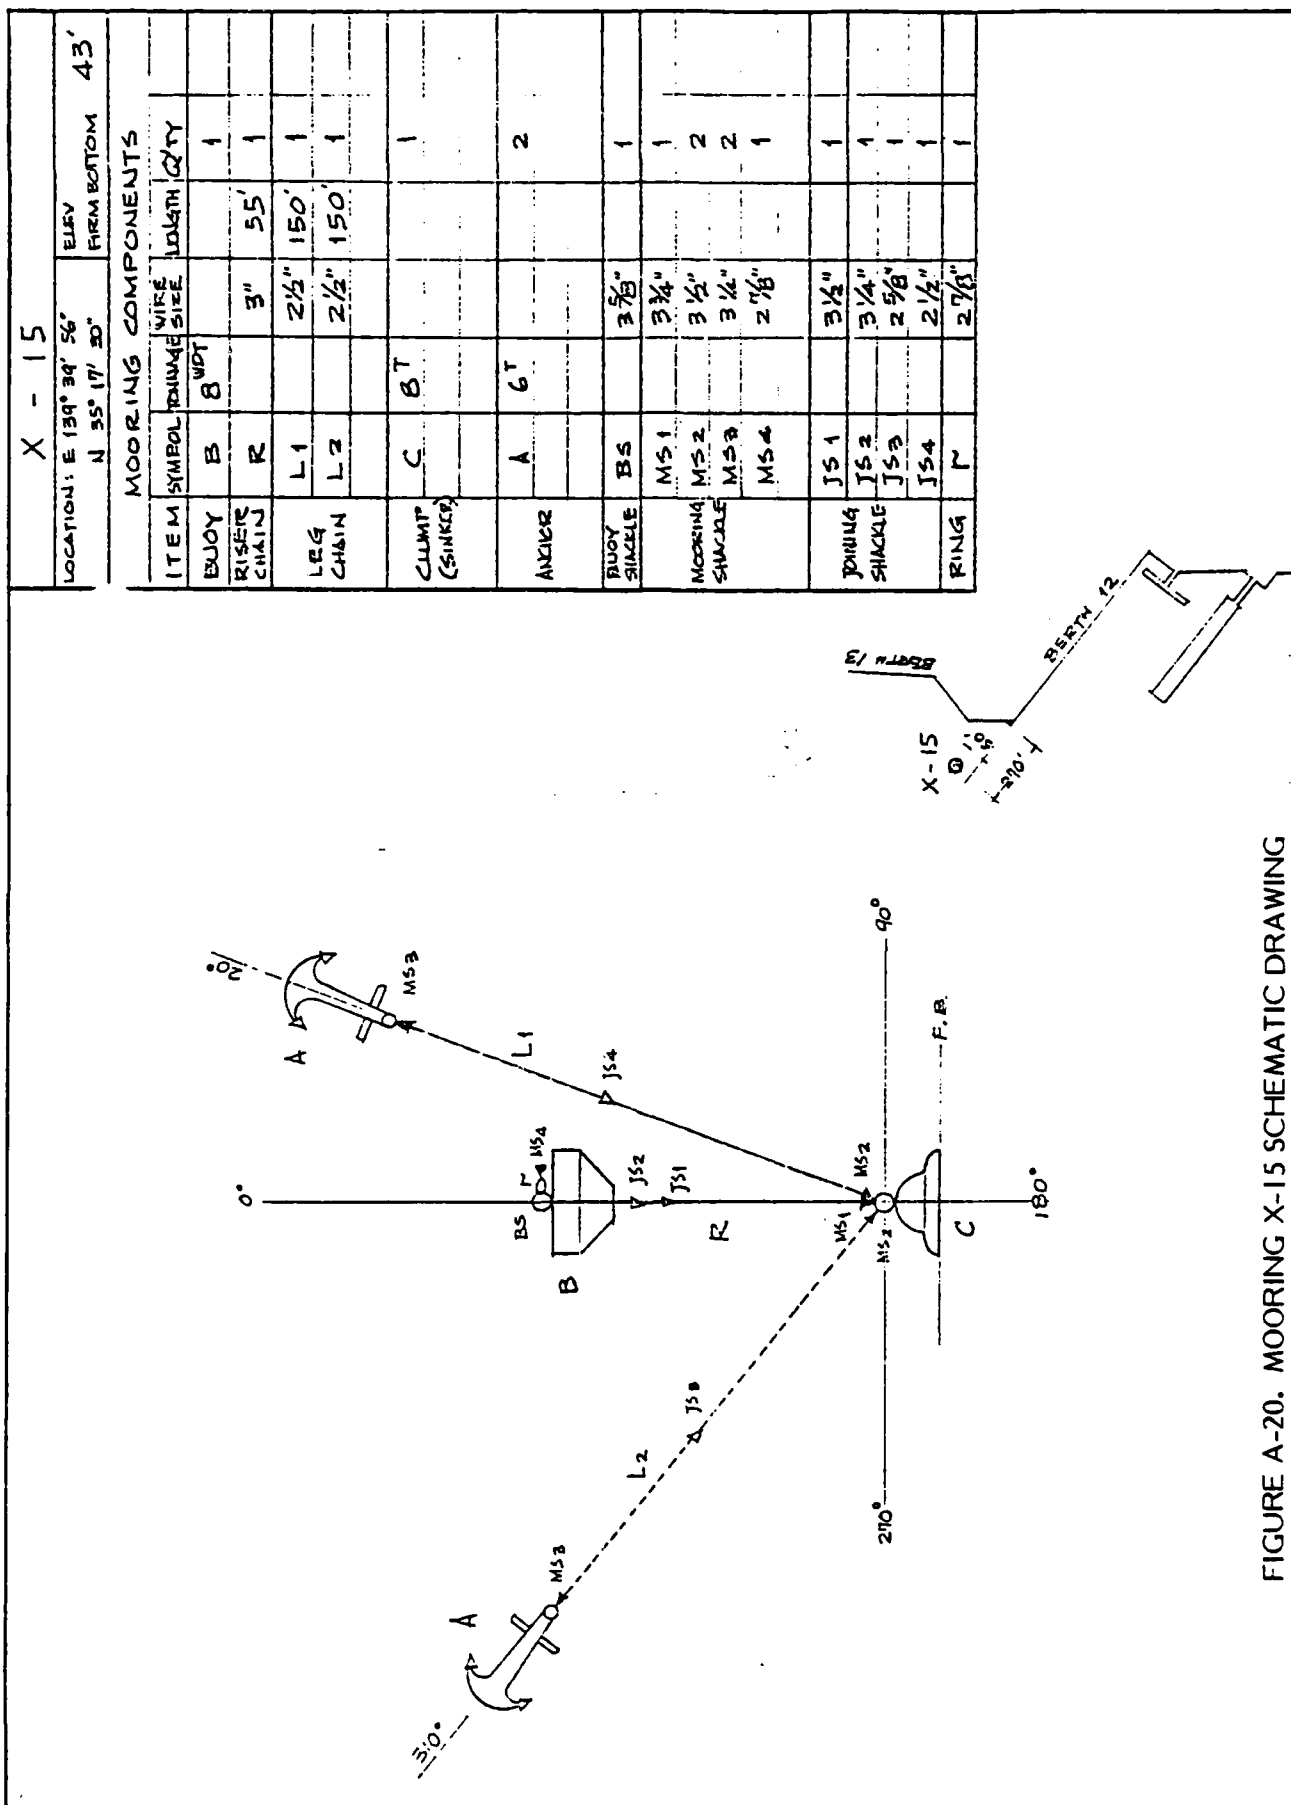
FIGURE A-20. MOORING X-15 SCHEMATIC DRAWING

COMPONENTS	NI	CONDITION						COMMENT
		NEW	SINGLE LINK %		DOUBLE LINK %		D	
			90+	80+	80-	90+	80+	80-
BUOY HARDWARE								
2" SHACKLE								FIBERGLASS CHIPPED/PEELING.
2 1/4" END LINK								CHAFING RAIL DAMAGED. RUSTY
2 1/2" SHACKLE								HOUSEPIPE. HOUSEPIPE RISER
4 1/2" SHACKLE								CHAIN RUSTED.
RISER		3"						
							<10'	
							20'	HEAVY MARINE GROWTH.
							40'	ENTERS BOTTOM
GROUND RING								
GROUND LEG NO. A								GROUND LEGS/SINKER/ANCHORS
								BURIED
GROUND LEG NO. B								
GROUND LEG NO. C								
GROUND LEG NO. D
